Technician Turbocharger Guide for the Powerstroke Engine

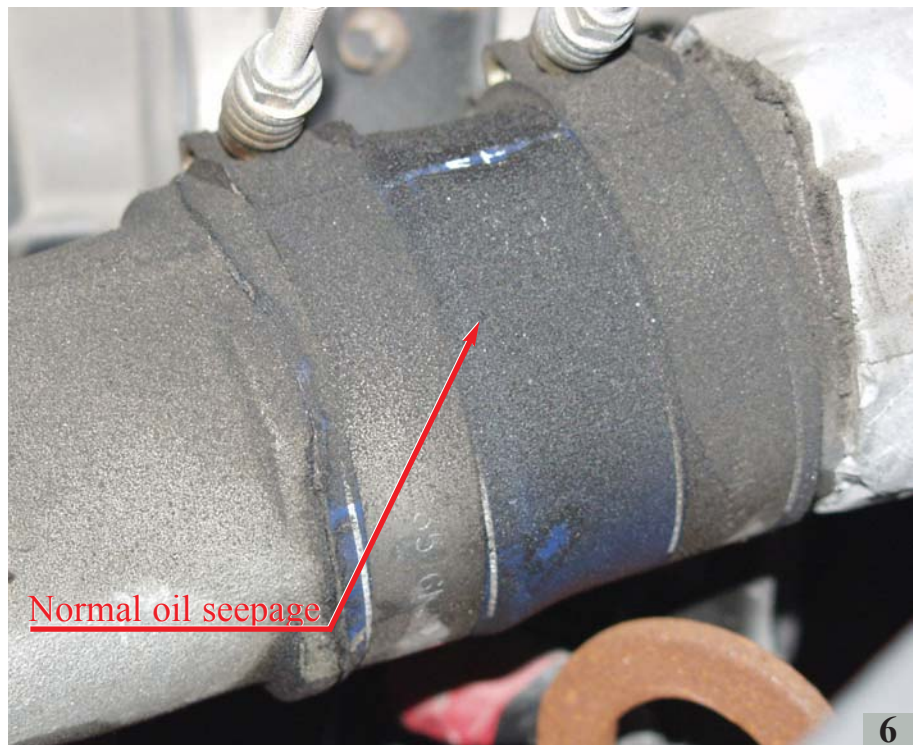
Normal Oil Seepage: The photo to the right shows normal oil seepage on the charge air cooler connections. This condition can be aggravated by excessive air inlet restriction or an overfilled crankcase oil level (refer to SSM 11982). The turbocharger should not be replaced for this condition.

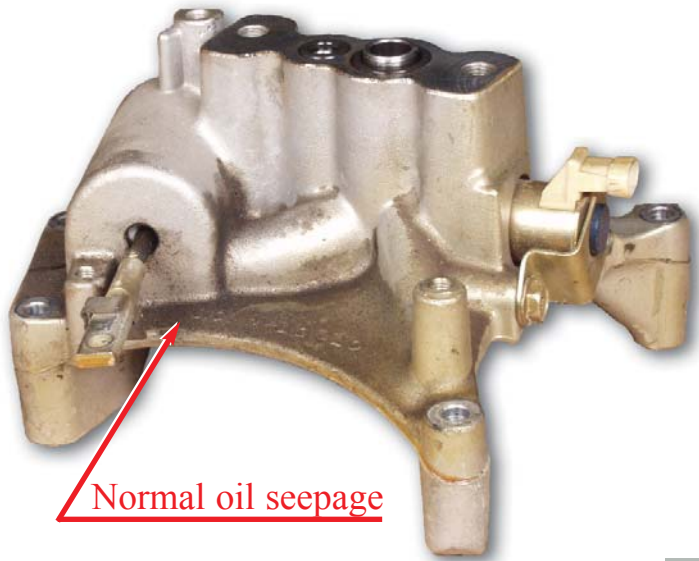
Normal Oil Seepage: It is normal to see some oil seepage past the seal on the EBP actuator rod. The photo to the left shows this normal seepage.

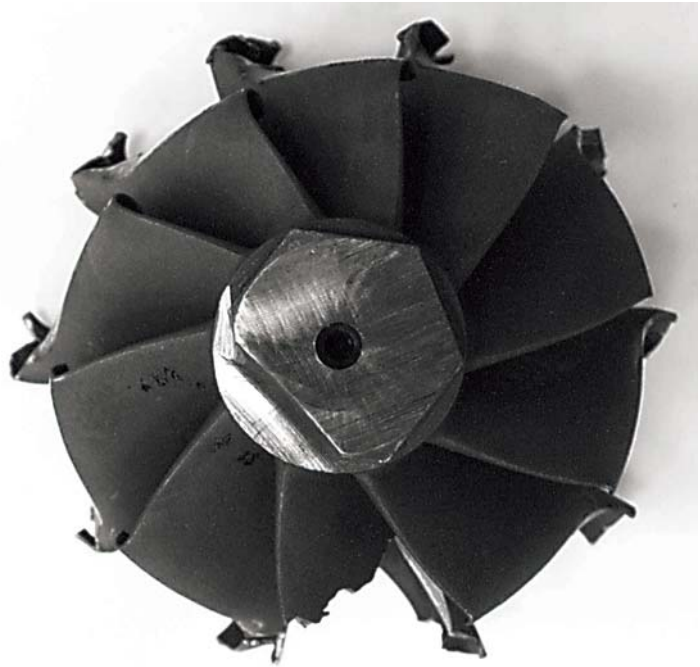
16

Structural Failure: Above right is a turbine wheel that has failed due to overspeed as a result of performance modifications.
